UPPER GILA RIVER FLUVIAL GEOMORPHOLOGY STUDY

FINAL REPORT ARIZONA

US Department of the Interior
Bureau of Reclamation

● DECEMBER 3, 2004 ●

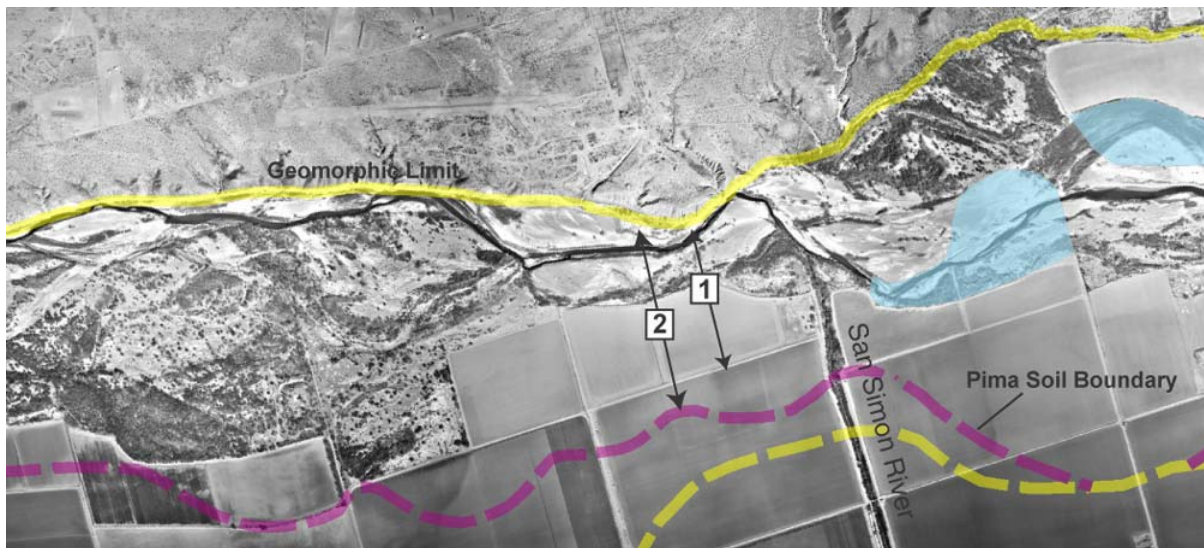
Figure 3. Illustration of Options 1 and 2 downstream of the San Simon River.

In Figure 3, Option 1 shows the average historical channel width in Reach 7 (see Table 1) while Option 2 shows the extent required to setback levees to the width of the Gila alluvium. Figure 4, located upstream of Solomon Bridge, also demonstrates the two options. Option 1 would essentially involve maintaining the current flood channel as a corridor free of levees. Although Option 2 requires a significant portion of agricultural land to be without levee protection, we contend that many of the levees have done more harm than good in causing extensive erosion of farmlands when levees fail during large floods. The reach upstream of Solomon Bridge is a good reach to demonstrate these concepts without critical infrastructure that require flood control and protection. In other areas where critical infrastructure exists, there will obviously be a need to maintain levees within the flood channel as well as within the Gila alluvium. This point is particularly relevant in Safford Valley, where diversions, bridges and canals are important for maintaining livelihoods and transportation routes through the region. The reach down-stream of Smithville Diversion illustrates an area where levees are necessary to protect Smithville canal and Thatcher Bridge. Downstream of Thatcher Bridge, levee setbacks are a viable option (Figure 5).

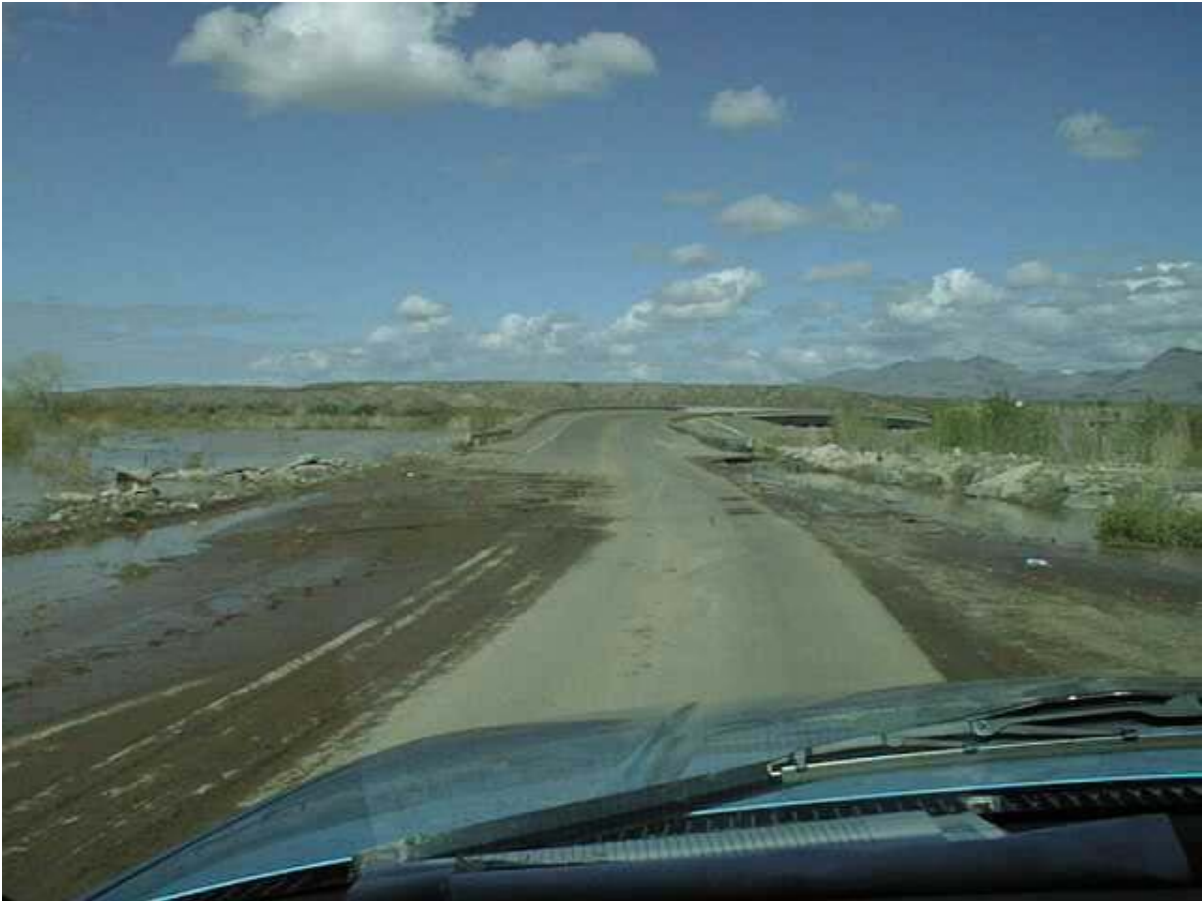
Figure 7. Left abutment and approach to Solomon Bridge. Note that the approach has recently been inundated (flow right to left) by floodwaters.

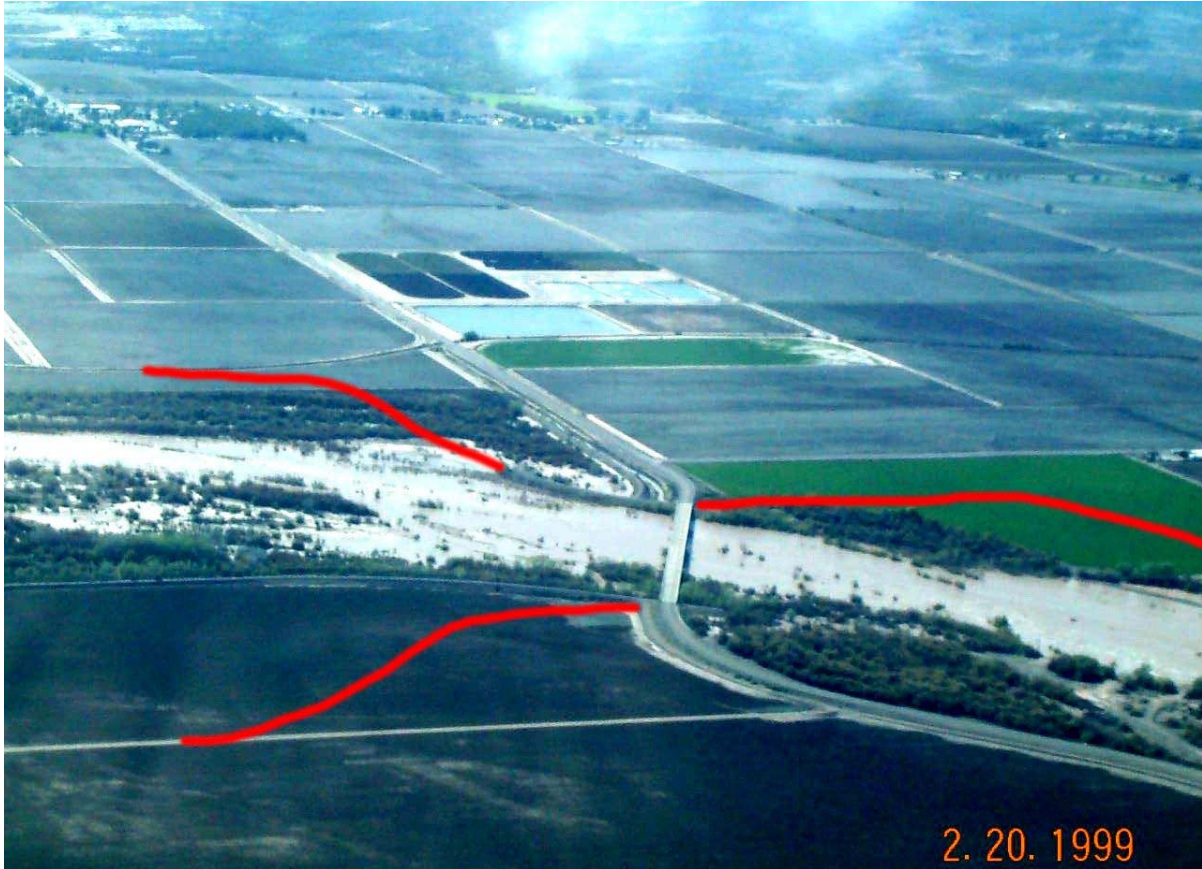
Figure 10. Potential levee realignment at Thatcher Bridge. (Flow is left to right)

Figure 10 shows an example of how a levee setback scheme could be transitioned into and out of the Thatcher Bridge section. The contraction upstream of the bridge may be shorter than the expansion downstream. It is important to minimize energy losses in the downstream transition and maintain sediment transport capacity. Otherwise, sediment may accumulate in the main channel, causing the river to shift left or right onto the over channel and floodplain. A similar integration of levees with diversion dams is also necessary.

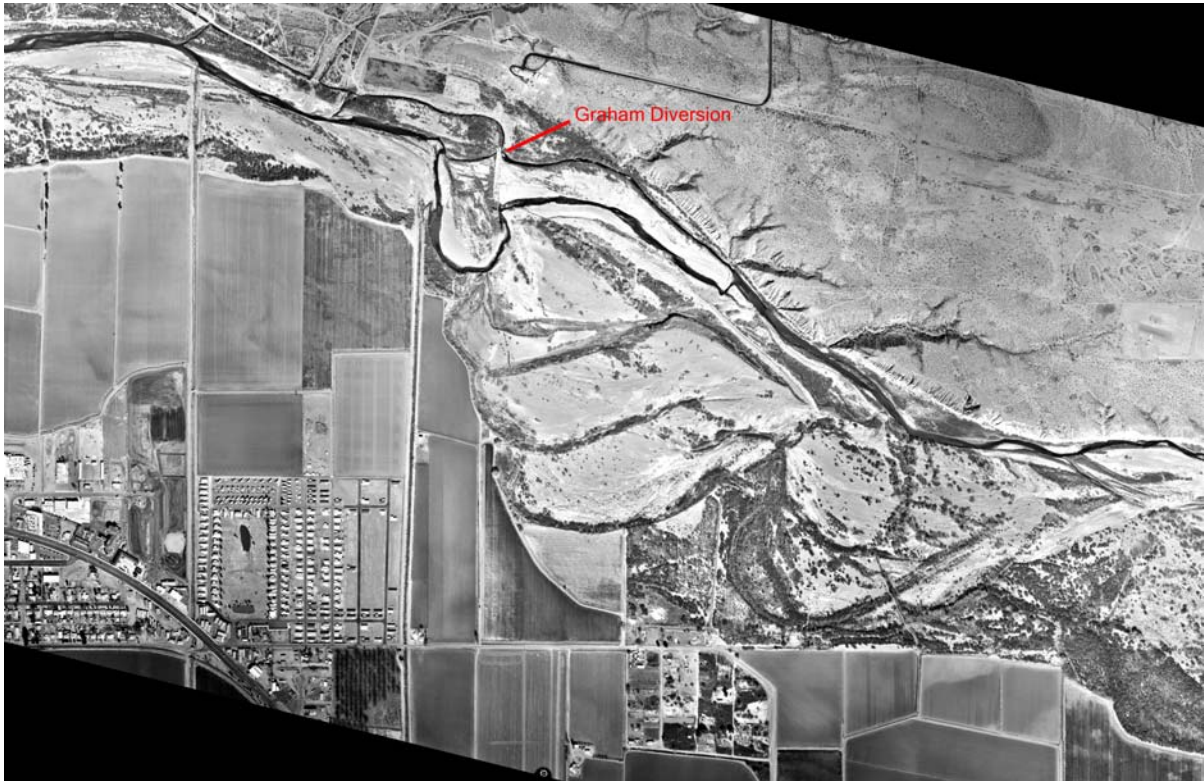
Figure 14. Area view east of Safford, Arizona. Graham Canal diversion dam is the cause of property loss in this area.

The Graham Canal Diversion Dam demonstrates the geomorphic consequences of interrupting the sediment budget in the Gila River. The current dam is roughly 300 feet wide, with an estimated hydraulic height of less than 10 feet. Figure 14 shows the area upstream of the diversion dam. The amount of land lost to erosion above the diversion is large. The maintenance costs associated with the diversion, namely excavating a channel to the headworks, and attempting to keep the river from flanking the structure entirely, are significant.

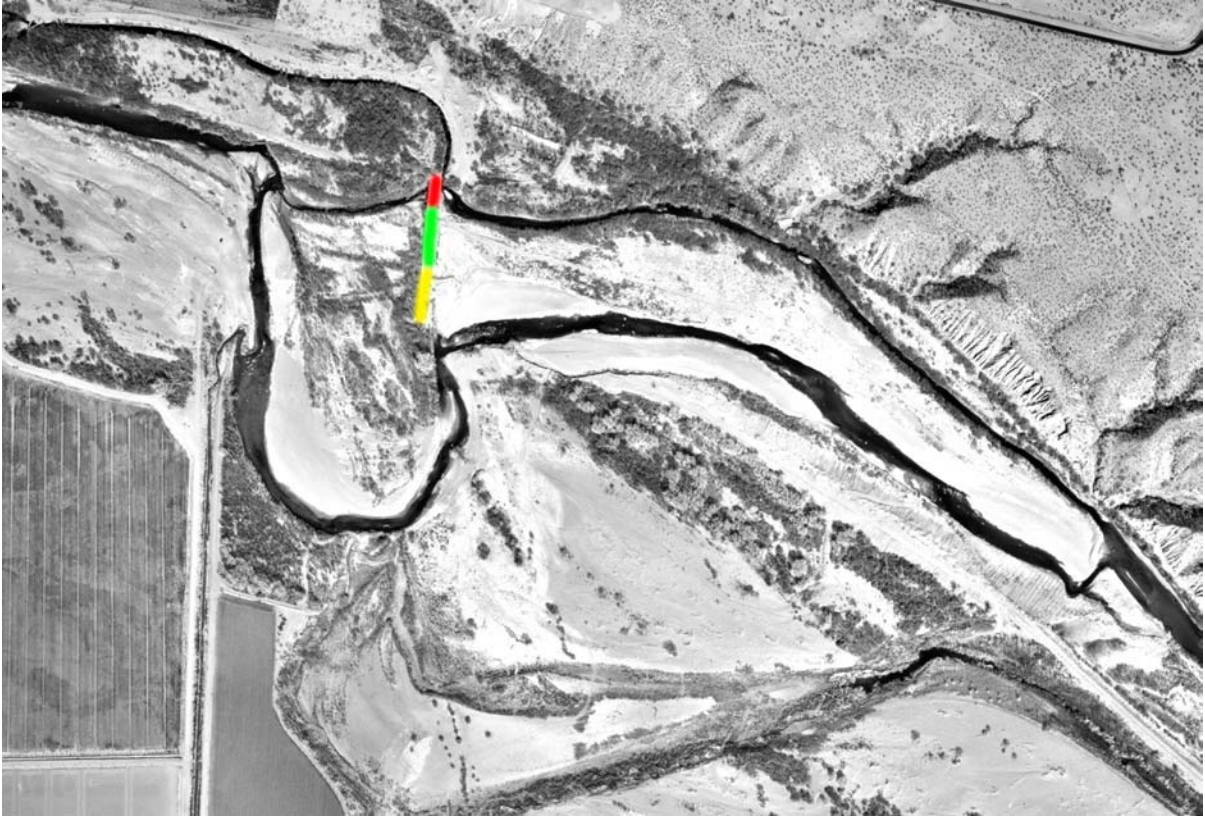
Figure 15. Location of the Graham diversion dam, and potential sections for replacement with rubber inflatable dam or Obermeyer Gate.

A potential partial solution is to replace a section of the fixed diversion dam with either an inflatable rubber dam or multiple sections of Obermeyer Gate. Figure 15 shows the diversion dam. The three colors represent sections of the dam. The red section is close to the headworks and should not be disturbed. The green section is the preferable section for replacement. It aligns well with the center of the channel, and could easily capture a large portion of intermediate flood flows. The yellow section is also a candidate for replacement. It is furthest from the headworks, and might need to be rebuilt in any case if the diversion dam is reconstructed.
